Thermography Inspection Report

Company	Westmoreland Electric
Author	Matthew A Fine
Date	10th June 2010

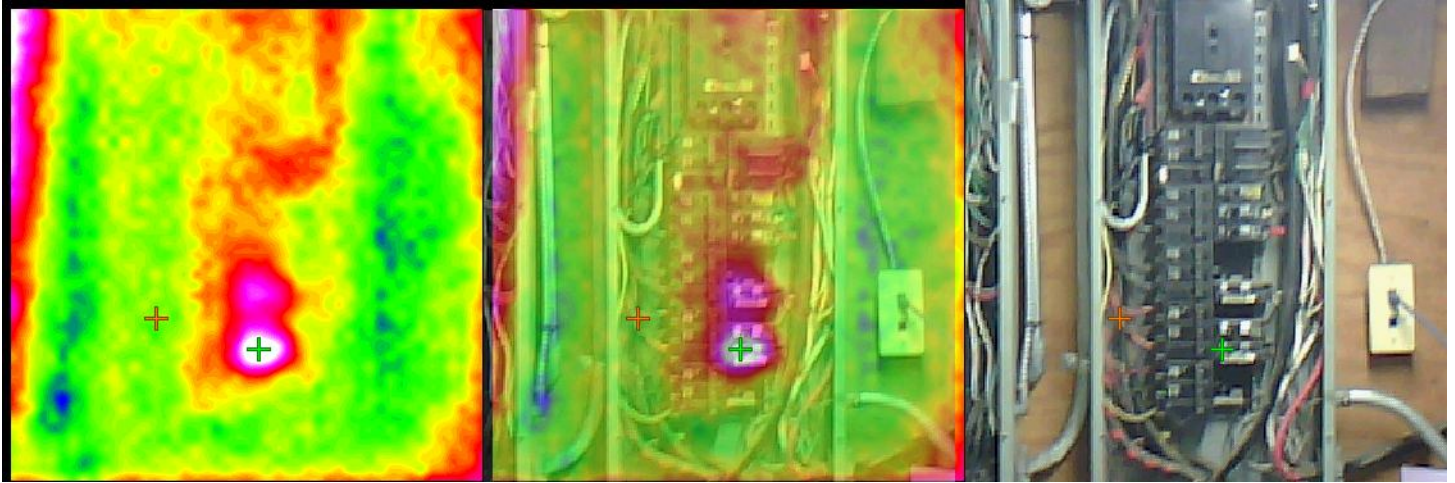
Inspection 1 - Right panel in walts room

GFI breaker slightly warm could be electronic problem within breaker

Cursor 1	85.4 °F
Cursor 2	79.0 °F
Difference	6.4 °F (Cursor 1 - 2)

Replace breaker

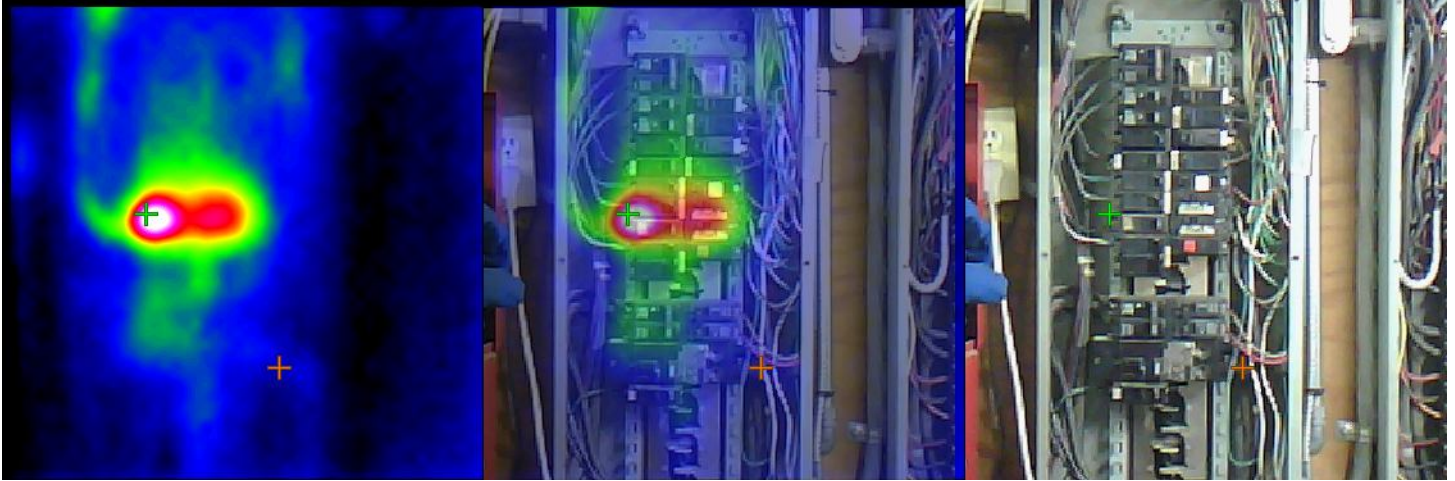
Inspection 2 - Right panel in Walts Room

Overloaded circuit breaker for basement lighting

Cursor 1	112.3 °F
Cursor 2	83.1 °F
Difference	29.2 °F (Cursor 1 - 2)

Add circuits for lights and split up

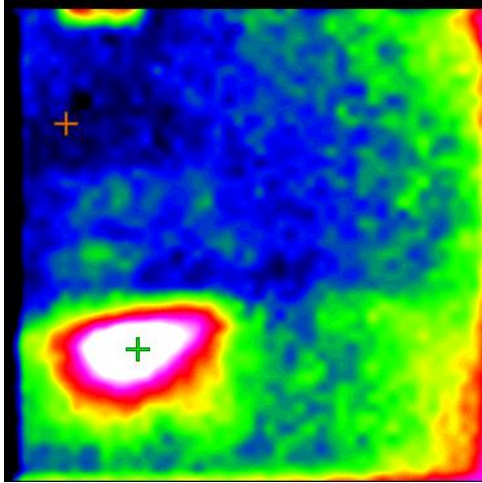
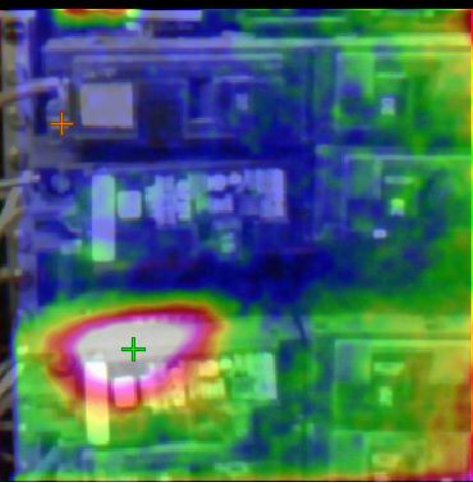
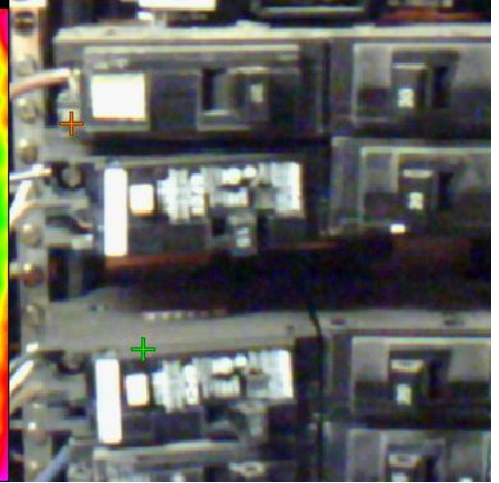
Inspection 3 - out building panel

GFI breaker slightly warm could be electronic problem within breaker

Cursor 1	89.0 °F
Cursor 2	71.4 °F
Difference	17.6 °F (Cursor 1 - 2)
