Thermography Inspection Report

Company	Westmoreland Electric
Author	Matthew A Fine
Date	10th June 2010

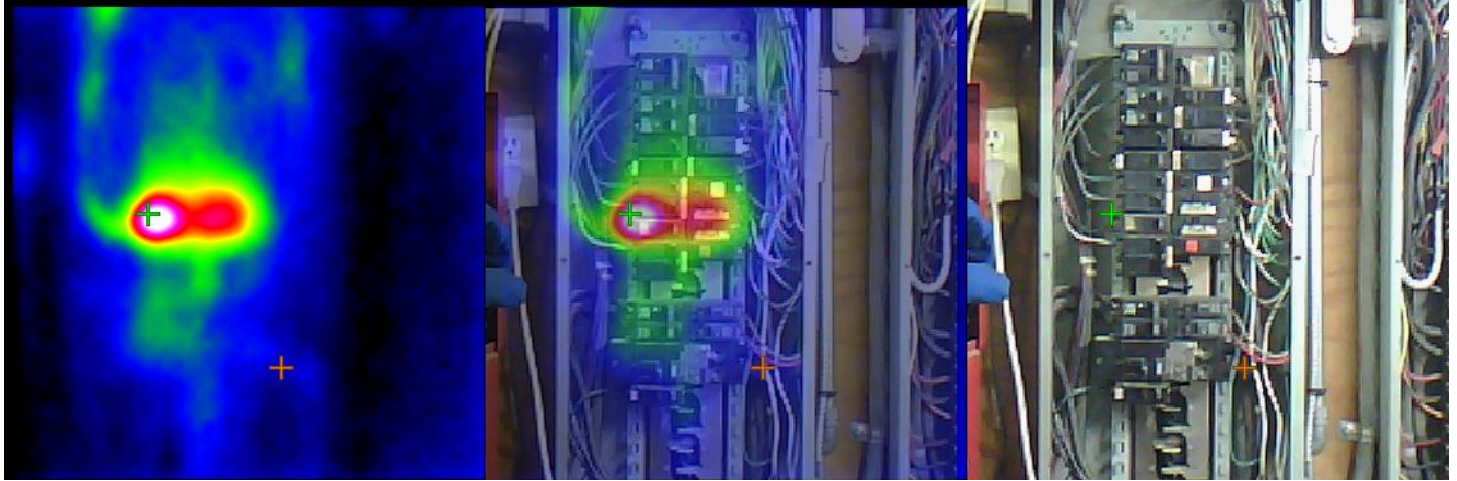
Inspection 2 - Right panel in Walts Room

Overloaded circuit breaker for basement lighting

Cursor 1	112.3 °F
Cursor 2	83.1 °F
Difference	29.2 °F (Cursor 1 - 2)

Add circuits for lights and split up

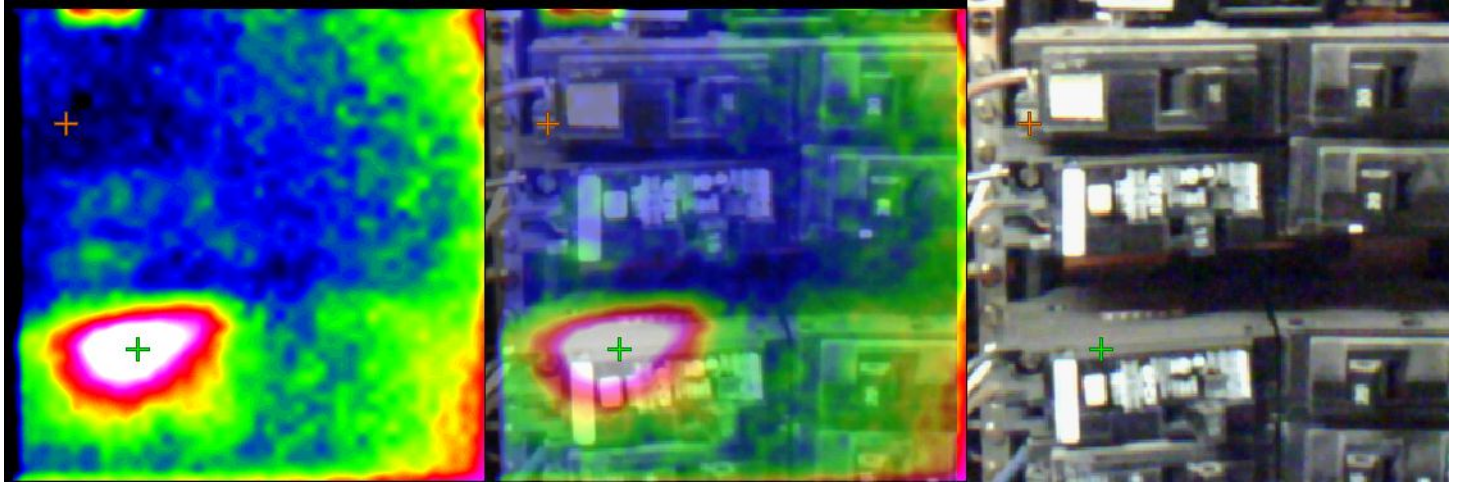
Inspection 3 - out building panel

GFI breaker slightly warm could be electronic problem within breaker

Cursor 1	89.0 °F
Cursor 2	71.4 °F
Difference	17.6 °F (Cursor 1 - 2)
