Examples of Thermographic Scans

Shown below are a few examples of thermograph scans and how they can be useful to determine electrical problems at a facility.

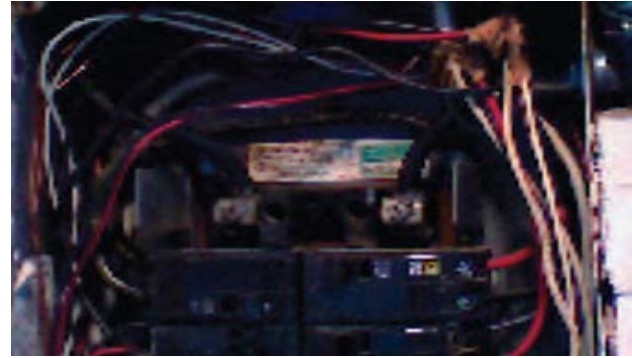
Figure 1 A high-resistance connection or component malfunction within a residential circuit breaker is easily seen in the thermal image, but not in the visible light image.

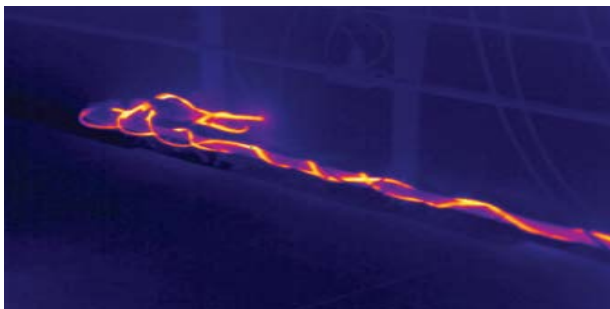
Figure 4 Thermography can even be used for applications such as troubleshooting a heating wire on an outdoor water line, which cannot be allowed to freeze in cold weather.
